Understanding the 17th Street Levee Canal Containment Wall Breach through pictures and a brief discussion

<u>Understanding the levee breach: a brief discussion of how the 17th</u> Street levee canal containment wall failed.

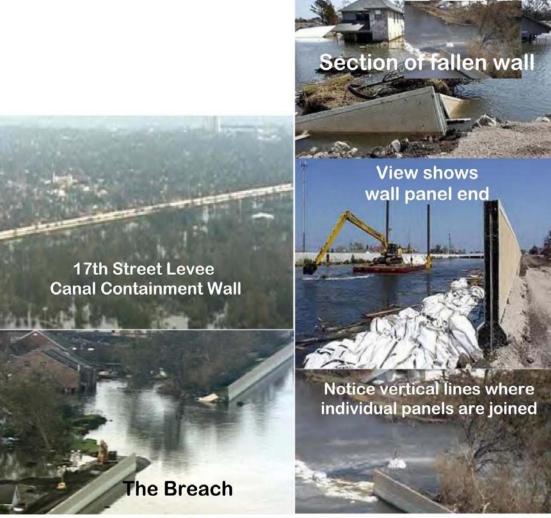
The containment wall is formed by a series of preform concrete panels joined end-to-end, and this wall is bedded in the earthern levee. A combination of two forces brought down sections of the wall -- hydraulic and gravity. Immense water pressure bears on the walls in times of high water levels in the canal. The same water pressure forces water to infiltrate the earthern levee, weakening it structurally. When the earthern levee is sufficently weakened, it begins to give way, and the panels above the "slump" lose that support. Then, it is only a matter of enough water pressure and gravity to effectively "drop" the panels, or enough water pressure to "blow out" panels when the water pressure against them overcomes resistance. Note how one panel was swept into an adjacent neighborhood.

The levee itself is earthen. The canal containment wall rests on, and is partially embedded in the earthen levee. This wall is formed by a series of preform concrete panels joined end-to-end.

Under pressure, water infiltrates ¹ the earthen levee. When the earthwork is loaded with water, hydraulic pressures weaken the forces ² within holding that earthwork together. Enough water will cause the earthen levee to slump as loosened soils move apart. Equally, the weakened earthen levee is more likely to be pushed or "blown out" by water pressure both from hydraulic pressure within the soil and from the flood water pushing laterally against it.

Once weakened to the point of slump or failure, the earthen levee no longer supports the panel or panels above. At this point, the panels are under the stress not only of water pressure pushing against them but also the force of gravity pulling down.

Bereft of support from below when the levee slumps or fails, the panels are bound to fail if sufficient water pressure pushes against them, and when they fail, they will almost certainly fail at the attachments -- individual panels will not break, but will tear away from their sister panels because the joints are the weakest point.
